NOAA/NWS METEOROLOGICAL ASSESSMENT FOR TYPHOON PONGSONA IN: POHNPEI STATE, FSM; CHUUK STATE, FSM; GUAM; AND, ROTA, CNMI

The National Oceanic and Atmospheric Administration (NOAA) National Weather Service (NWS) Meteorological Assessment Team for Typhoon Pongsona

April 2003

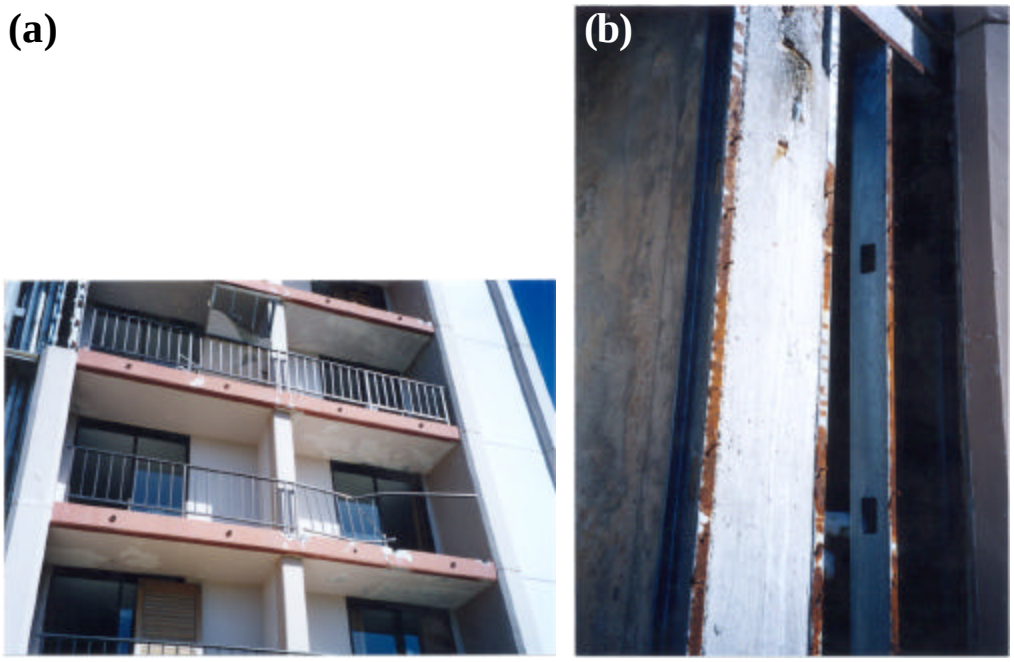
b) Hotel. Flying debris damaged the balcony railings to some parts of a high-rise building facing Tumon Bay, but the doors opening on to those balconies were visibly still intact (Figure 17a). The lightweight concrete covering panels were ripped off an exterior column and a portion of this building also lost several lightweight exterior wall panels. However, it was not possible to verify the type and condition of the connectors; the photograph (Figure 17b) shows some rusted attachment points. There was no visible damage to the building's main structural system.

Figure 17. (a) A major hotel in Lower Tumon. Note the in-tack doors leading to the balconies. **(b)** Missing lightweight exterior wall panels of a lower Tumon hotel, with very small rusted attachment points of connectors and the appearance of glue residue. (NOAA Photos)**.**

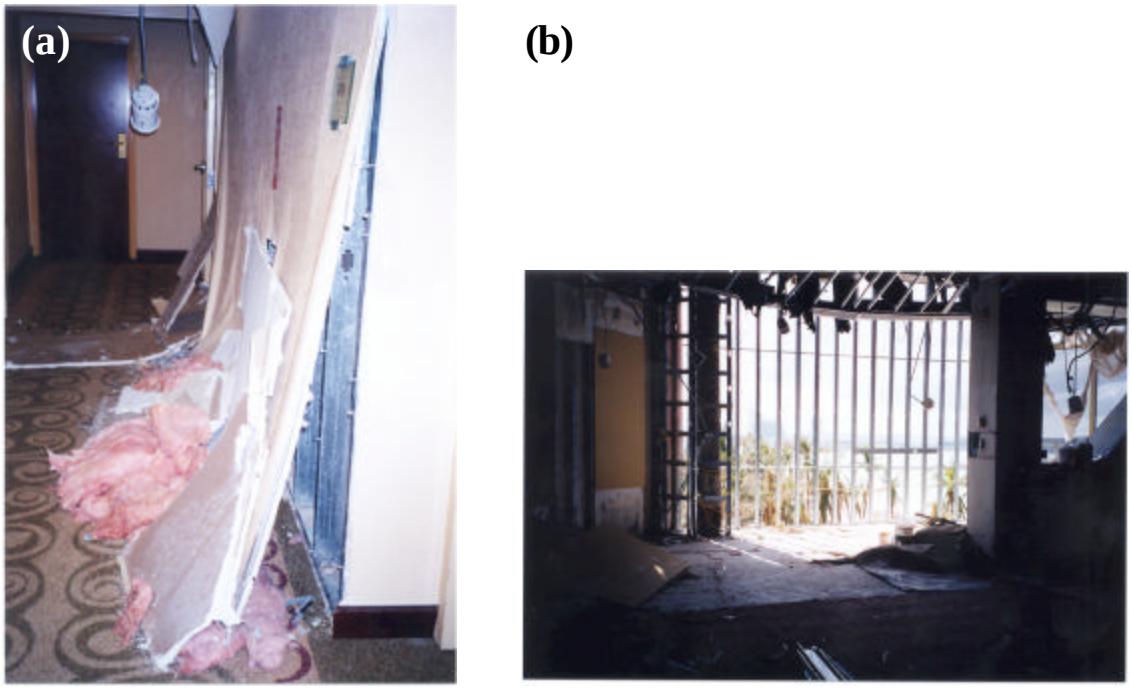
c) Hotel. A major hotel at Tumon Bay sustained severe broken glass windows facing the bay. The breakage permitted the winds to breach the building envelope and the sudden build-up of internal pressures damaged some of the hallway dry-board walls (Figure 18a) and blew out some of the lightweight external wall material (Figure 18b). Several windows and sliding glass doors at the lobby level were broken. There was no damage to the building's main structural system.

Figure 18. (a) Blown in interior wall of a major Upper Tumon hotel. **(b)** Blown out exterior wall of a major Upper Tumon hotel. (NOAA Photos)
